# Stabilisation of Landslides using DSM columns in New Zealand

Author: A O' Sullivan, G Quickfall, S Terzaghi

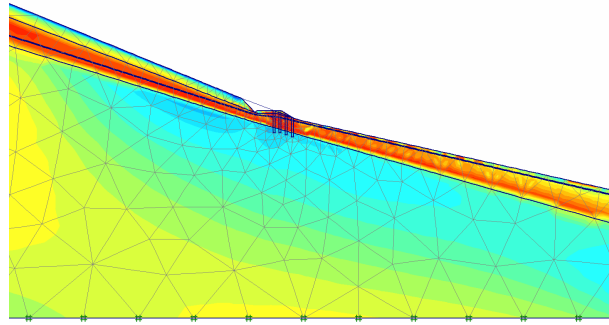
**Figure 2:** Plaxis analysis cross-section showing critical failure mechanism under High groundwater table

The initial back-analysis of the slope captured the shallow infinite slope failure well (refer figure 2 above). However, the installation of the columns and modelling of the group effect was more difficult as a result of the contractive behaviour of the soil. Figures 3a & b 4a & b below show the pre- and post-DSM installation results. In this case, the contribution of the confining pressure of the columns (volumetric expansion of binder injection) needed to overcome the contractive nature of the soil. This required a reduction in column spacing from the originally adapted design.

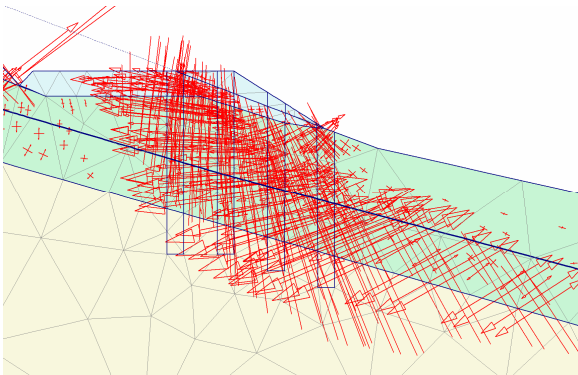
**Figure 3a:** Shear Strains pre-installation

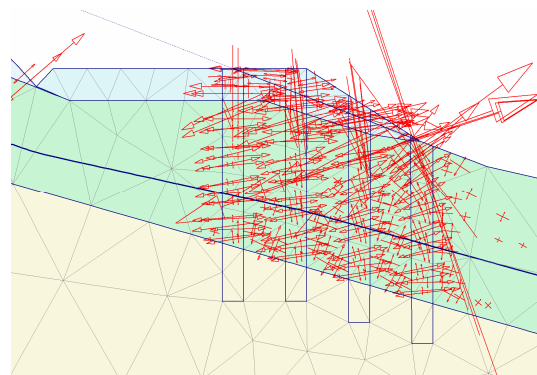
**Figure 3b:** Shear Strains post-installation (reflecting volumetric expansion of column installation)

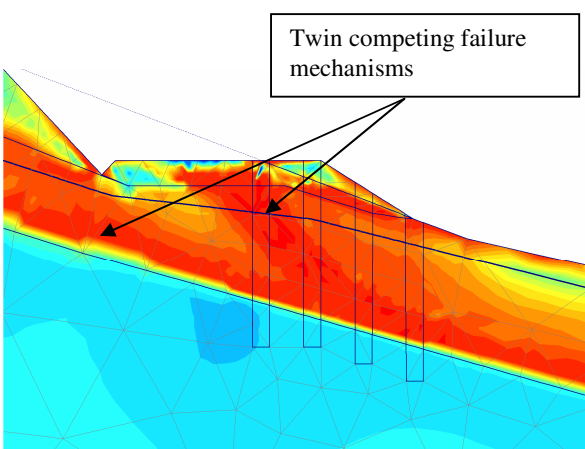
**Figure 4a:** Critical Mechanisms prior to installation

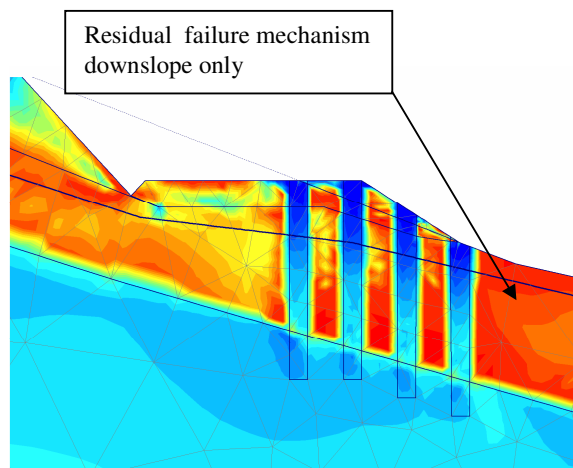
**Figure 4b:** Treated Zone following installation

The project has been successful to date with the DSM columns preventing a failure of the road for the first time over successive winter seasons.

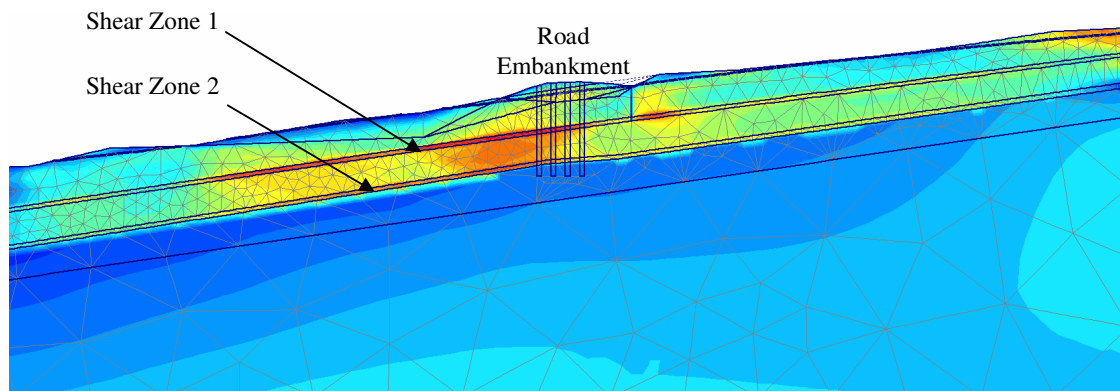
*Figure 5: Plaxis Design profile for Ogles 3 site indicating two shear zones*

Using the parameters obtained from the laboratory testing, the back analysis of the slope indicated that the FoS under a high groundwater table was in the order of 1.5. However the road embankment was still subject to deformation. This indicated that the slope “failure” was not a typical Mohr Coloumb type strength failure, but was being caused by a response to two phenomena namely (a) transient groundwater flow and (b) the response to a dynamic load of a truck passing through the site when the site was in a fully saturated state. This resulted in an temporary (split second) instantaneous undrained failure of the slope.

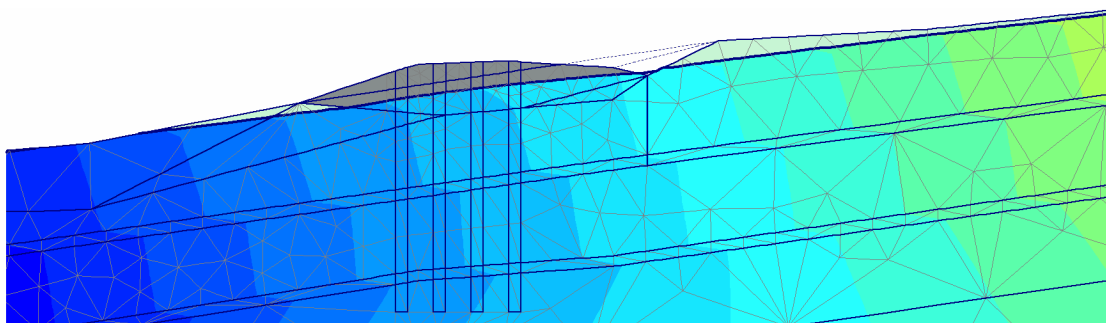
*Figure 6: Output from transient groundwater flow reflecting measured groundwater head profile on site*

While exact correlation between the FE model and the in-situ groundwater profile could not be obtained, given the tight timeframe (only 2 months allowed from commencement of site investigation works to completion of the works), the model did indicate a very good correlation between the deformations predicted by the model when compared to the deformations obtained in the field by the installed inclinometer (16mm and 13mm respectively). This was deemed sufficiently close to ensure that the model was calibrated correctly for this analysis.

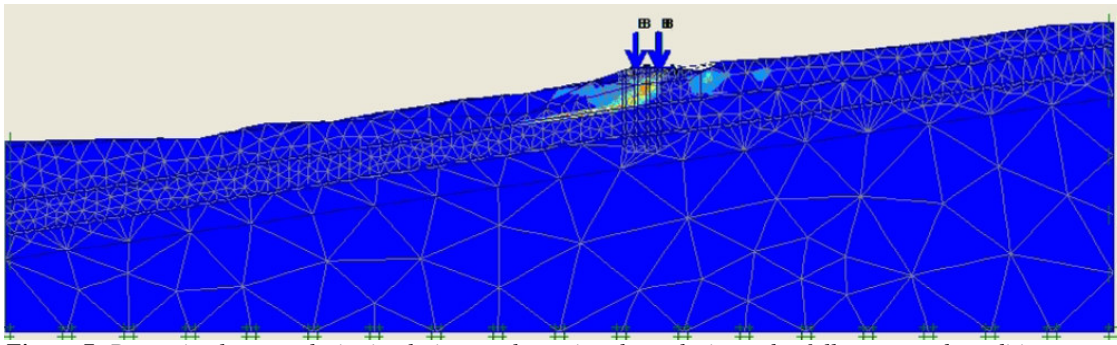
*Figure 7: Dynamic phase analysis simulating truck passing through site under fully saturated conditions*
