# An update of Deep Soil Mixing in New Zealand

Graeme Quickfall, NZCE (Civil), REA, MBA  
Andy O' Sullivan, BE, CEng, MIEI, MIPENZ, Eurlng  
Isaac Kett, ME (Civil)

Hiway Stabilizers Environmental Limited - Auckland, New Zealand

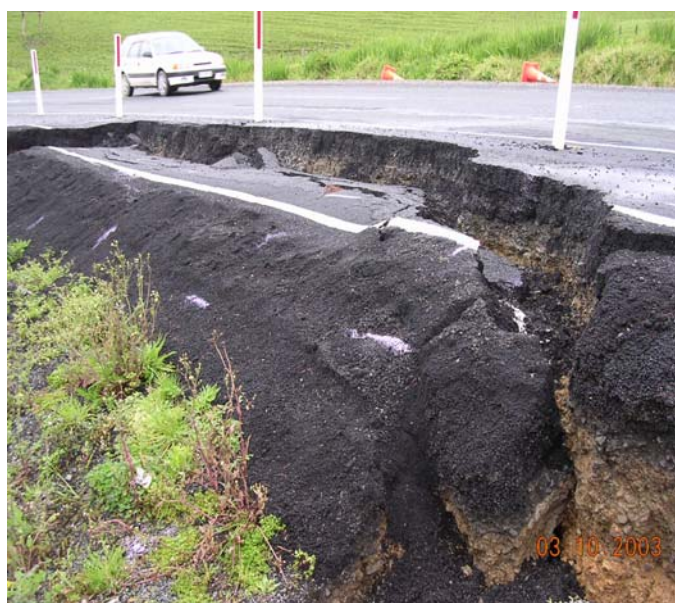
Figure 1 (left): A typical New Zealand road under slip.

New Zealand's geology generally comprises a range of young and geotechnically challenging soils. In particular Northland and the Gisborne region on the North Island's east coast are prone to instability of road structures. As a result, New Zealand roads have long suffered from over and under slip settlements, many associated with increase pore water pressure build-up and/or weak soil properties. A photograph of a typical road under slip is shown in Figure 1.

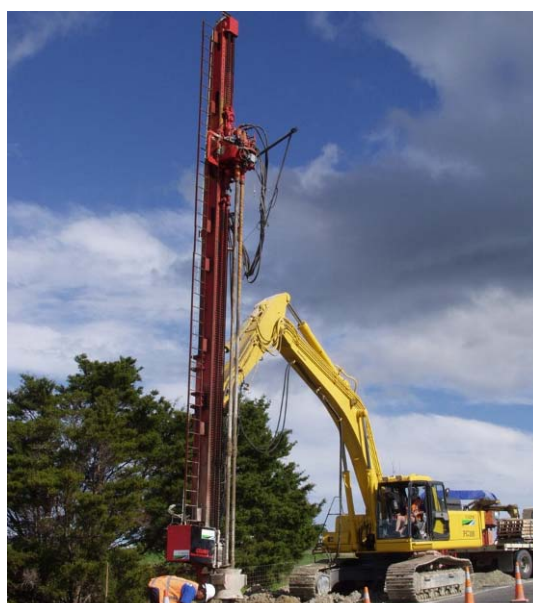
Figure 2 (right): The Colmix C1300 rig

In 2002, Hiway Stabilizers took delivery of a "wet" soil mixing system named Colmix, which Hiways considered to be most appropriate for New Zealand applications. This is a proprietary method developed by Soletanche Bachy, utilising multiple augers to achieve highly efficient mixing and resultant soil mixed columns - the system is illustrated in Figure 2. Binder slurry is mixed in a batching plant and pumped through the hollow stemmed augers where the grout is discharged at the drill head. The batching, pumping and drilling is a computer controlled and monitored process

The auger arrangement comprises twin overlapping discontinuous flight augers. Binder is injected during the insertion phase to achieve soil homogenisation and lubrication of the mixing tool. During the extraction phase, the augers are reversed and along with an applied downward thrust, thus providing efficient compaction of the soil column.

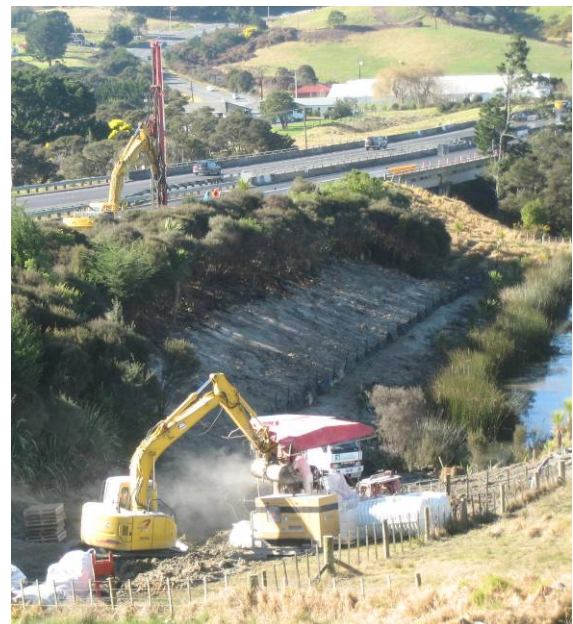
Figure 5: Installation of DSM columns at Okura.

A DSM solution was adopted that involved the drilling of 83 columns drilled to a depth of 8.5 m. The columns were divided into 7 rows of which 4 were constructed at the base of the slope, and 3 were constructed adjacent to the pavement shoulder. Safety factors of 1.5 and 1.2 were adopted for the normal and extreme groundwater conditions, as displayed in Figure 4. The remedial works, as illustrated in Figure 5, were completed in 2.5 weeks.

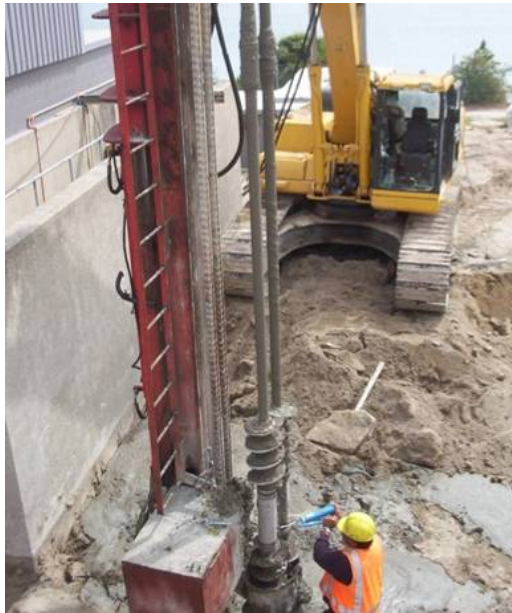
Figure 6: Tauranga WWTP site.

The 500mm wide DSM wall was constructed to provide a 70mm overlap - this created 8.5m cells upon which the liquefaction mitigation design was based. 171 columns were constructed in total. The perimeter wall encompassed 62 m<sup>2</sup> with 7 cells created by internal walls. Construction took place in March 2006 and required a great deal of attention to be placed on the location of each column due to the required overlaps and the presence of substantial services due to being located in the WWTP. Columns were drilled to 11.5m maximum depth, creating significant construction challenges. The site and cells created by overlapping columns are illustrated in Figures 6 and 7.

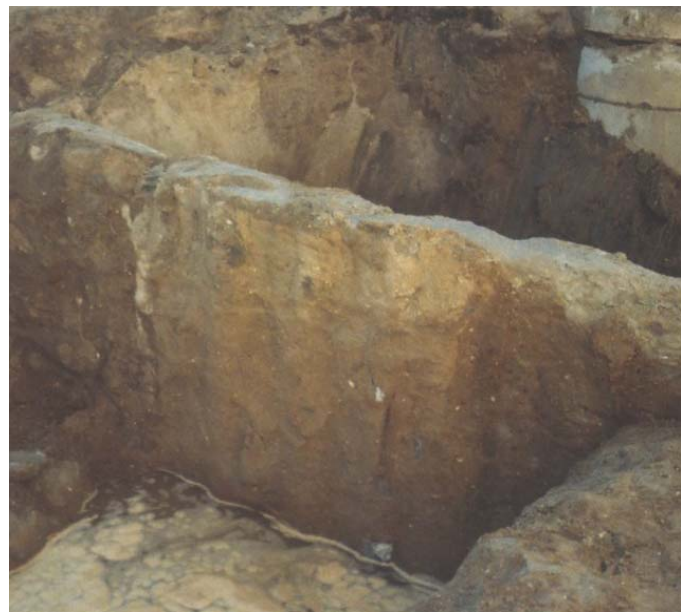
Figure 7: Overlapping columns creating cells.

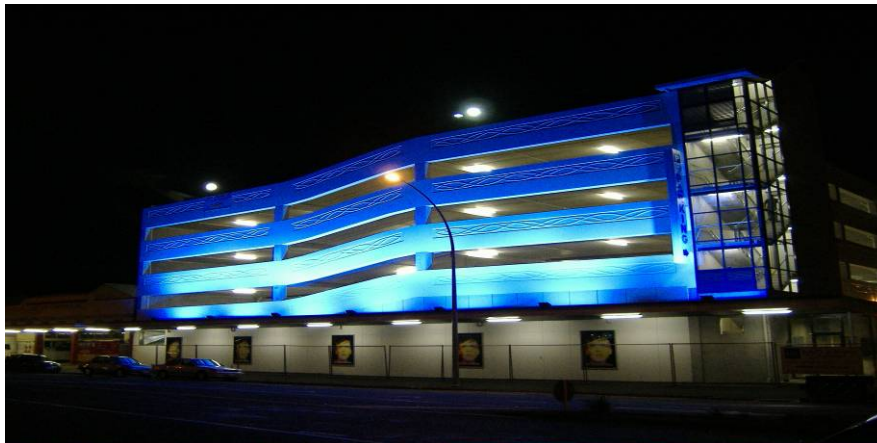
Figure 8: Knox Street Carpark, Hamilton - Inaugural use of DSM in building foundations.

Due to the DSM columns being permanently placed below the reinforced concrete building, post construction monitoring has not been conducted. Being an “alternative” design and the first application of DSM for building foundations, the pre-contract investigations plus construction monitoring were increased to a high standard. The building is performing as expected and no concerns have been raised since construction was completed. The carpark is shown in Figure 8.
