# Stabilisation of Landslides using DSM columns in New Zealand

Author: A O' Sullivan, G Quickfall, S Terzaghi

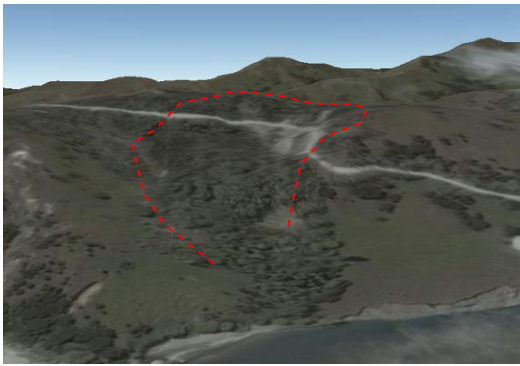
The road at Kaiianga runs through an active shallow landslide, 180m below the head scarp. The cause of the failure mechanism is a combination of toe erosion and high contrast in permeability between the upper residual soil layers and the underlying moderately weathered rock layers. The problem is exacerbated by the high shrink/swell characteristics of the residual soil, which result in a high extent of fissuring in the drier summer months and hence are more susceptible to rapid ingress of precipitation during the early part of the wet winter months.

Every year, during heavy winter rainfall events, the unsealed road gets washed away and the community in the hinterland is completely cut-off. A number of solutions had already been tried at the site, including re-grading the road, reducing the slope angles and installing extensive drainage works.

**Figure 1:** Satellite Image of Kaiianga Slip  
(Courtesy Google Earth Pro)

Given the success of DSM on the local state highway network, the local Council considered a DSM option. While only limited site investigation information was available (CPT's to 7m) a preliminary design indicated that a DSM based solution would be viable and economic based on targeting only the faster shallower movements.
